Bridge Assessment Number 3

Bridge Name	Duncan District
River	Ruby
Bridge Location Description	Duncan District
Bridge Coordinates (Lat., Longitude)	N 45 deg. 26.034 min. W 112 deg. 15.438 min.
Accessibility Assessment (safe as is, safe with work, not safe)	<ul style="list-style-type: none"> • Single Lane Bridge—parking should be reviewed • NE Corner access is ok—best current access • NW Corner is blocked by fence topped with strand of barbed wire • SW corner access is ok but could be improved by removing barbed wire in way • SE Access is obstructed by debris
Notes: (What would make it safe, why is it not safe as is, etc.)	Remove barbed wire at SW corner; find place for creation of road-pullout for 2 vehicles within walking distance.
Name(s) of person conducting review	Dave Delisi, Jerry Kustich, John Eisenbarth
Date of review	4/17/09

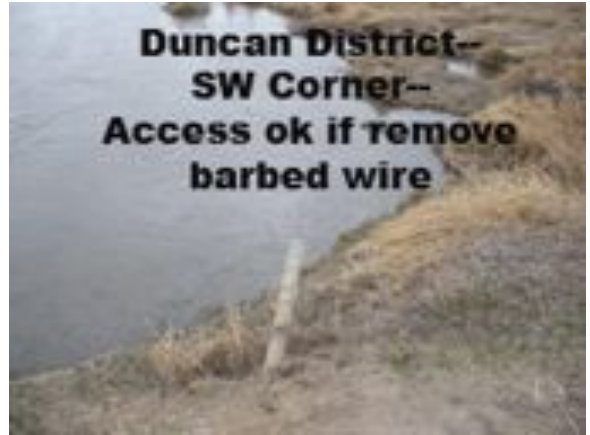
**Duncan District--
SW Corner--
Access ok if remove
barbed wire**

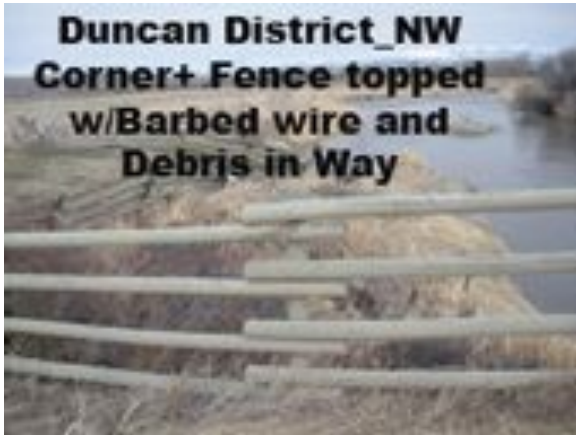
**Duncan District_NW
Corner+ Fence topped
w/Barbed wire and
Debris in Way**
