Bridge Assessment Number 3

Bridge Name	Duncan District
River	Ruby
Bridge Location Description	Duncan District
Bridge Coordinates (Lat., Longitude)	N 45 deg. 26.034 min. W 112 deg. 15.438 min.
Accessibility Assessment (safe as is, safe with work, not safe)	<ul style="list-style-type: none"> • Single Lane Bridge—parking should be reviewed • NE Corner access is ok—best current access • NW Corner is blocked by fence topped with strand of barbed wire • SW corner access is ok but could be improved by removing barbed wire in way • SE Access is obstructed by debris
Notes: (What would make it safe, why is it not safe as is, etc.)	Remove barbed wire at SW corner; find place for creation of road-pullout for 2 vehicles within walking distance.
Name(s) of person conducting review	Dave Delisi, Jerry Kustich, John Eisenbarth
Date of review	4/17/09

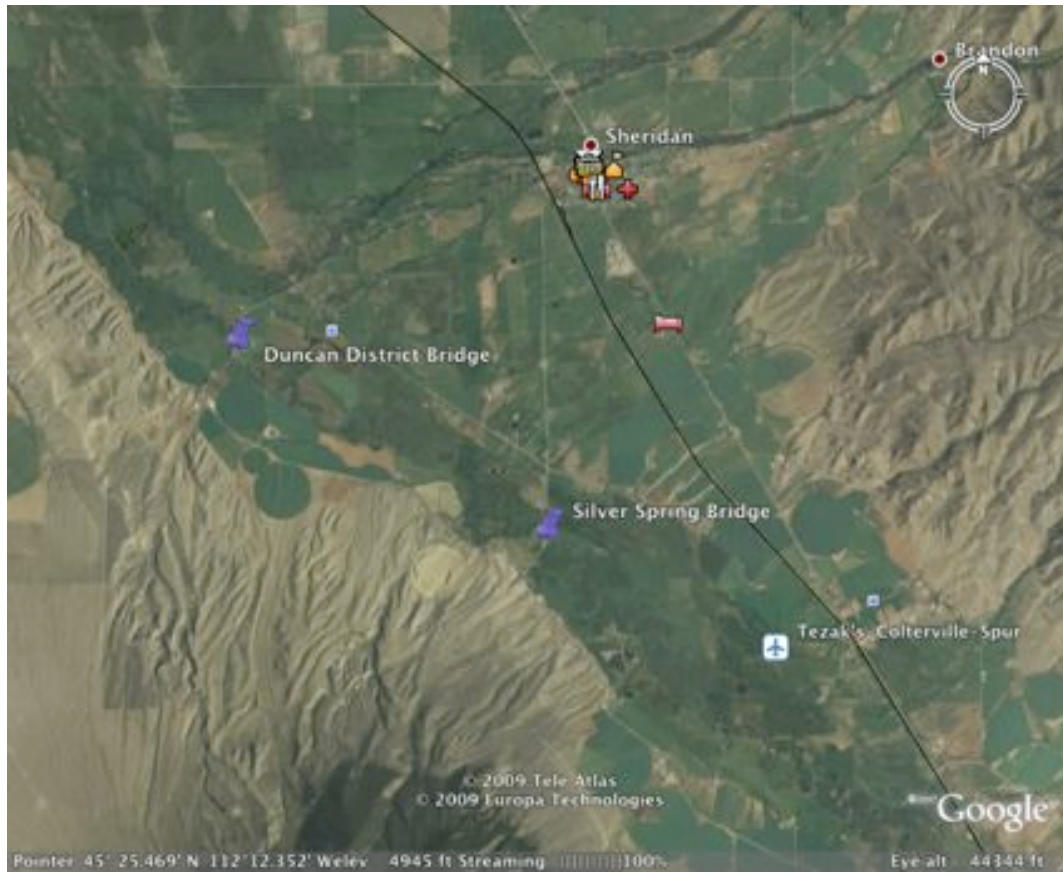
Photos:

Bridge Name	Silver Spring
River	Ruby
Bridge Location Description	Silver Spring
Bridge Coordinates (Lat., Longitude)	N 45 deg. 24.685. min. W 112 deg. 12.341 min.
Accessibility Assessment (safe as is, safe with work, not safe)	<ul style="list-style-type: none"> • Safe as is • Currently maintained as an Access Site; parking is excellent and access to river is also good • It must be noted that, as with all fishing Access Sites along the Ruby, Silver Spring is a temporary Access Site permitted by the current landowner from whom the site is leased. Should that landowner change hands, as happened at Coy Brown Bridge Access Site, the public may lose access to that site. Vigilance should be paid to ensure Access Sites such as Silver Spring and Alder Bridge are not lost.
Notes: (What would make it safe, why is it not safe as is, etc.)	
Name(s) of person conducting review	Dave Delisi, Jerry Kustich, John Eisenbarth

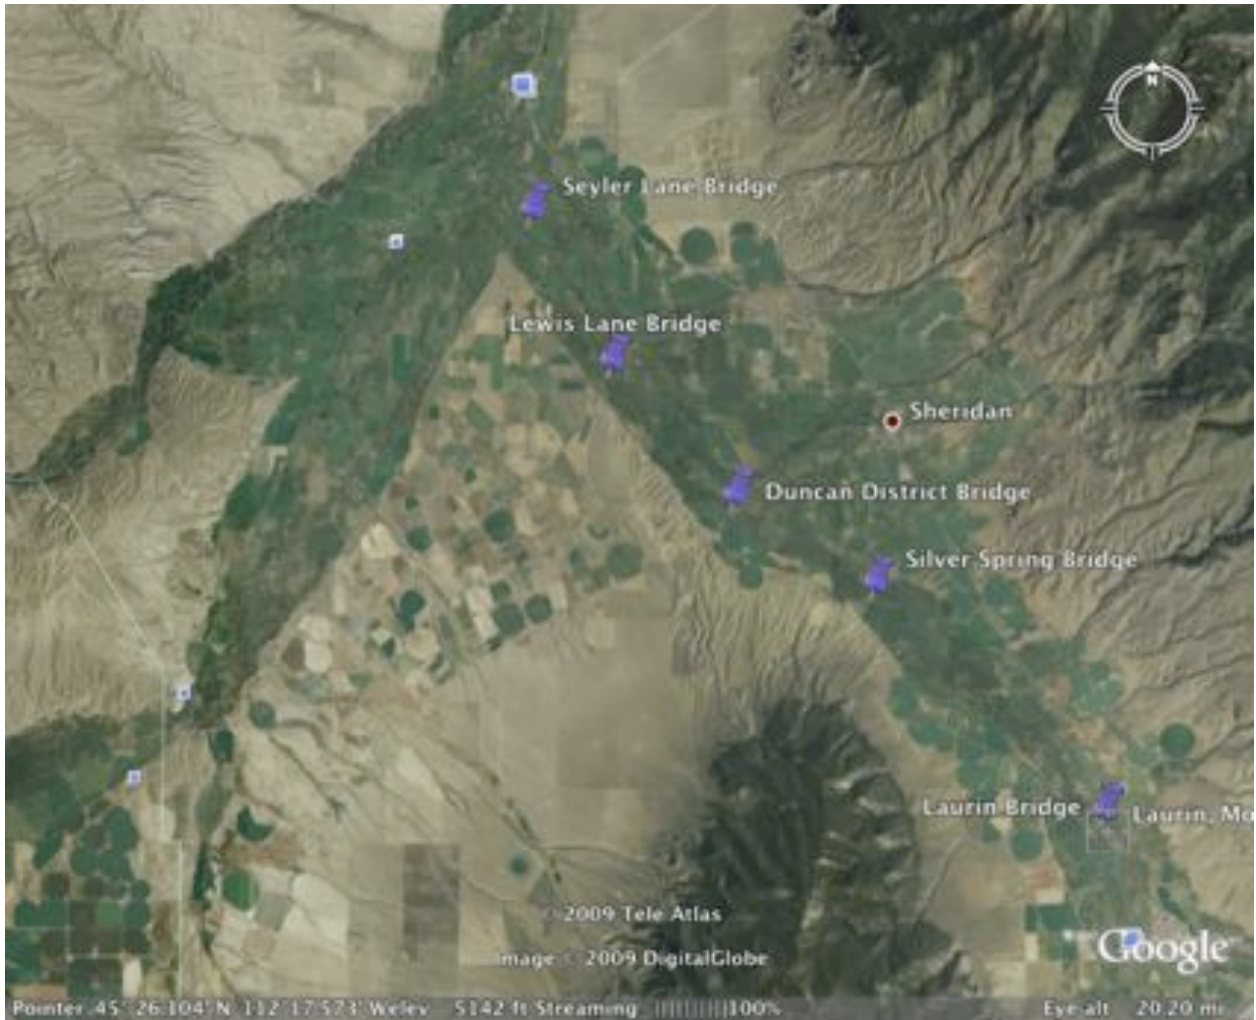
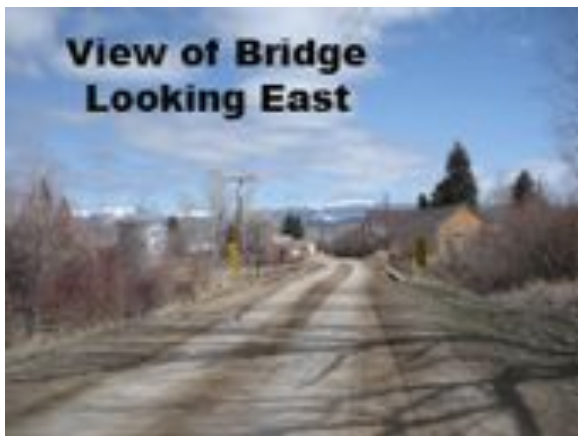
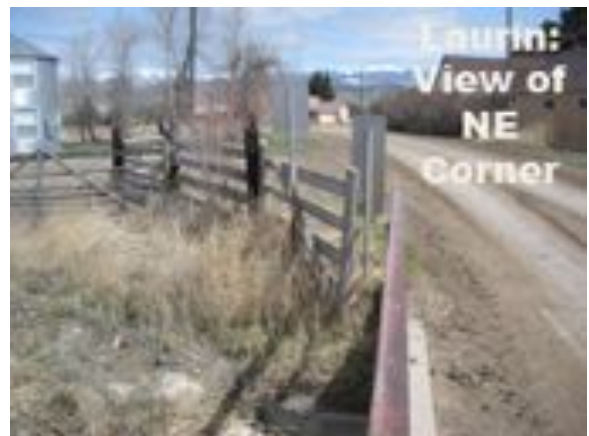
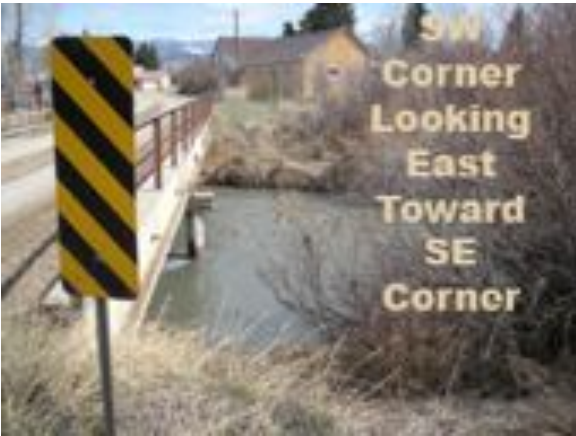
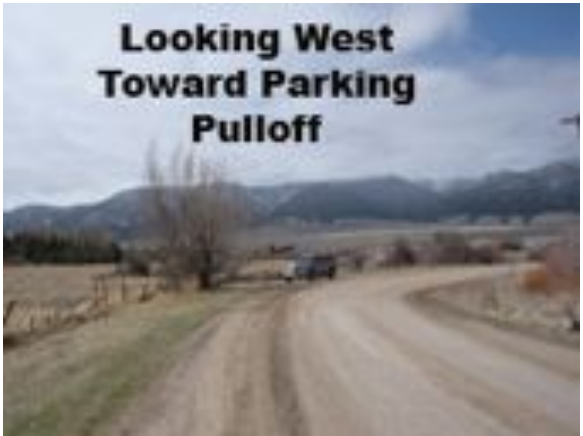
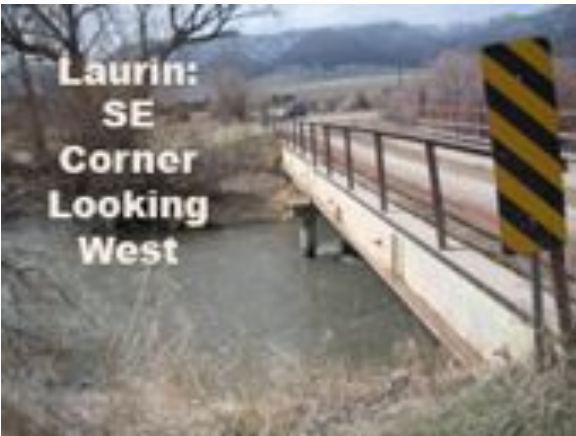
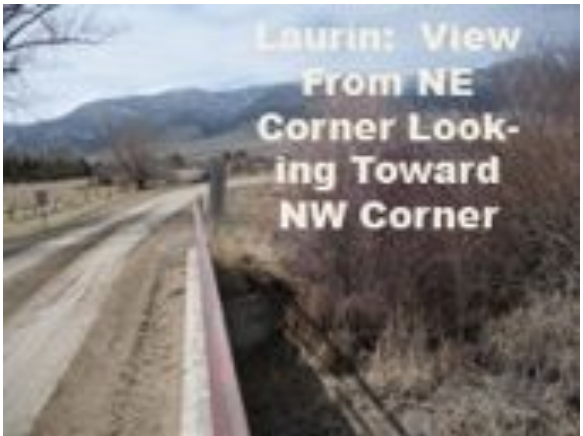
Photos:

Bridge Name	Laurin Bridge
River	Ruby
Bridge Location Description	In town of Laurin
Bridge Coordinates (Lat., Longitude)	N 45 deg. 21.160 min. W 112 deg. 7.324 min.
Accessibility Assessment (safe as is, safe with work, not safe)	<ul style="list-style-type: none"> • Good access from 2 of 4 corners; some parking 100 yards west of bridge on south side of road; should be reviewed • SW Corner access is good, although water may be deep during high water events • NW Corner is blocked by abutment that drops 4' vertically • NE corner is blocked by fence and abridge abutment • SE Access is good—unobstructed, clear access to good water
Notes: (What would make it safe, why is it not safe as is, etc.)	Additional parking may be available by parking in town of Laurin; this option should be reviewed
Name(s) of person conducting review	Dave Delisi
Date of review	4/17/09
